Protecting our Infrastructure in Streams

Allison Walker - Citizens Energy Group
Andrew Miller - Christopher Burke Engineering

2023

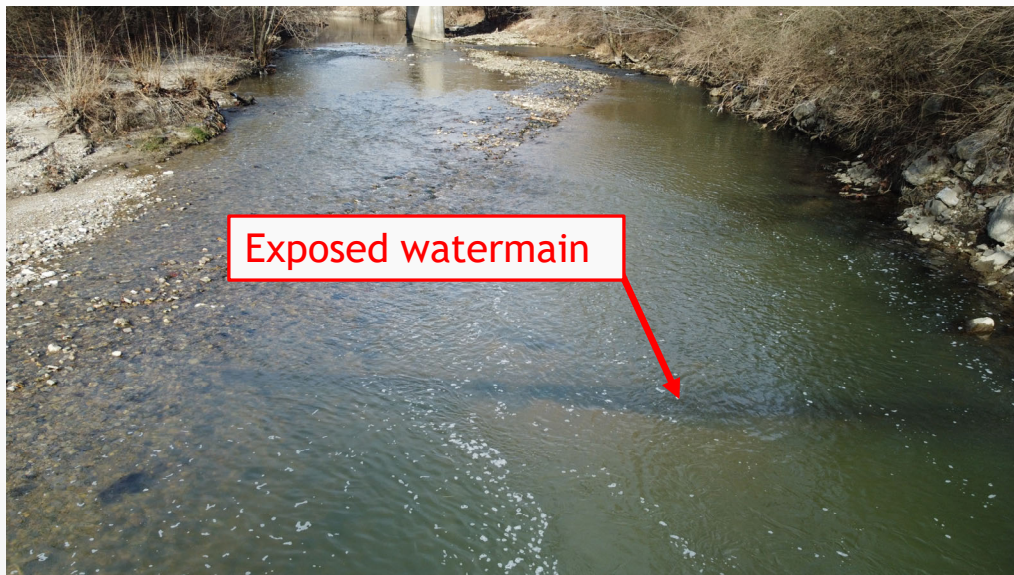
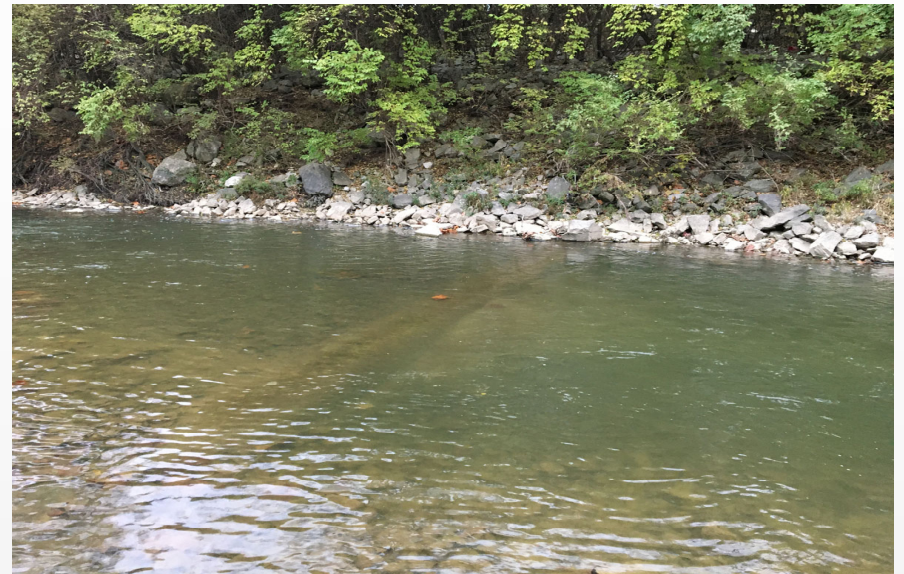
Existing Condition

- 36” Watermain
 - Main transmission line. Can not be taken out of service
 - Levee on south bank
 - 30’ elevation change on both banks
 - Floodway (IDNR Permit Required)

Solution: Newbury Riffle

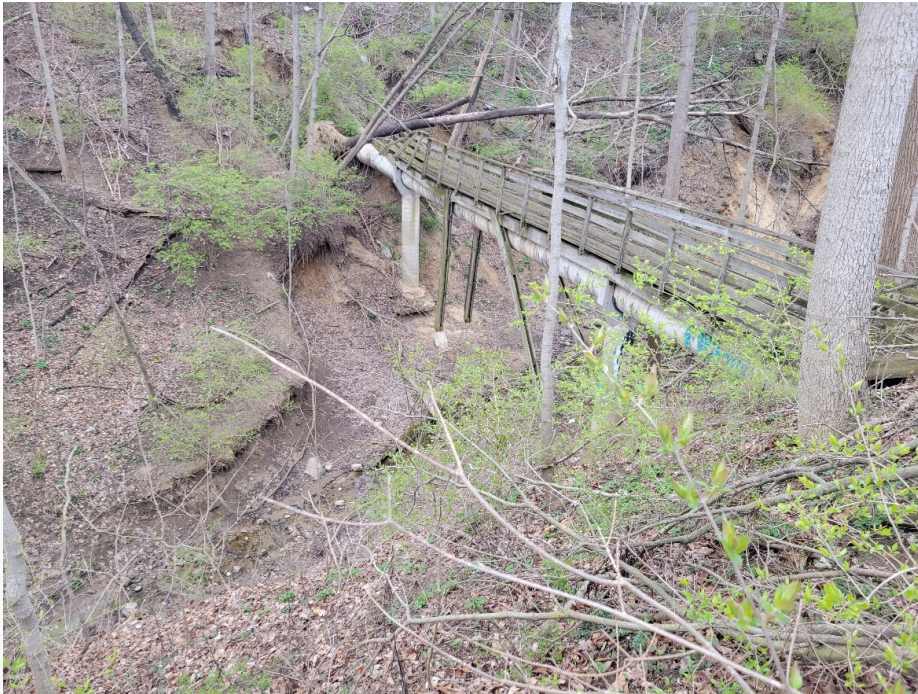
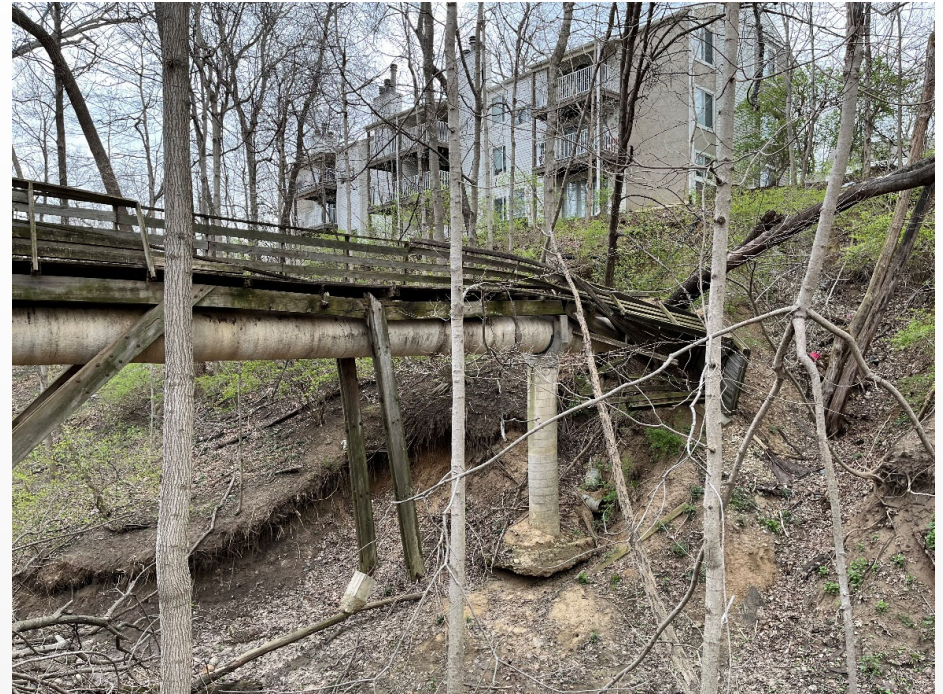
Existing Condition

- 24” Aerial Sanitary Sewer
- Abandoned wooded bridge
- Exposed pier
- 40’ banks with sever erosion
- Limited access
 - White River
 - Apartment buildings

- Re-route
 - Not feasible
 - Multiple lift stations
- Instream improvements
 - SMR: Bad
- Reinforced infrastructure
 - Cost: 1.0M

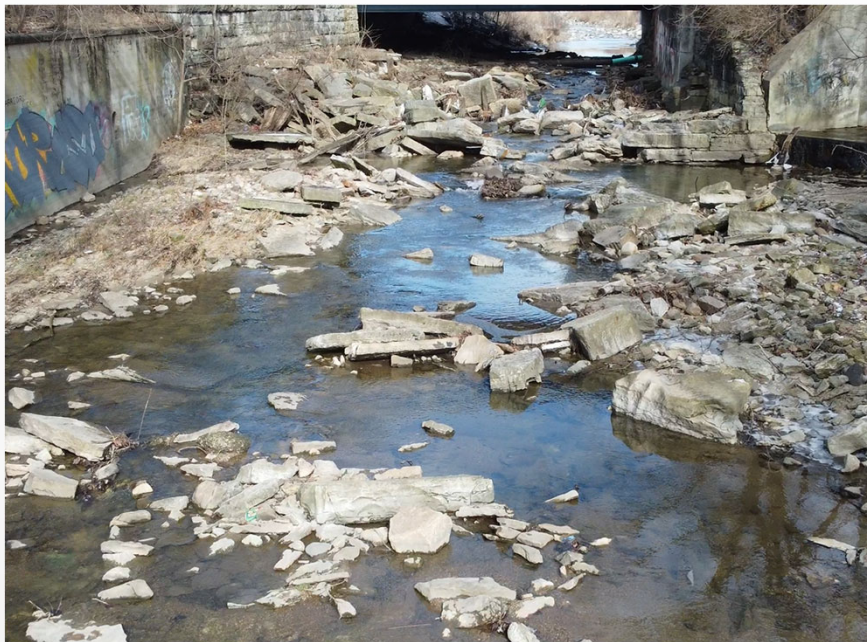
Debris from dam

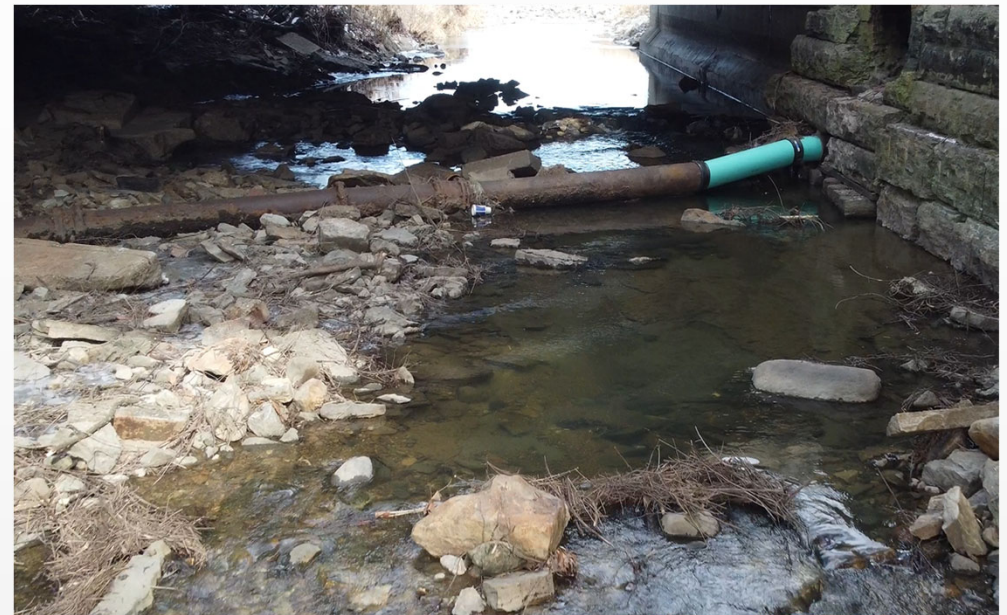
Exposed sanitary

- Relocation
 - Possible but very high costs
- Instream structures
 - Riffle at each utility
 - Boulder cluster
 - Rock cross vane

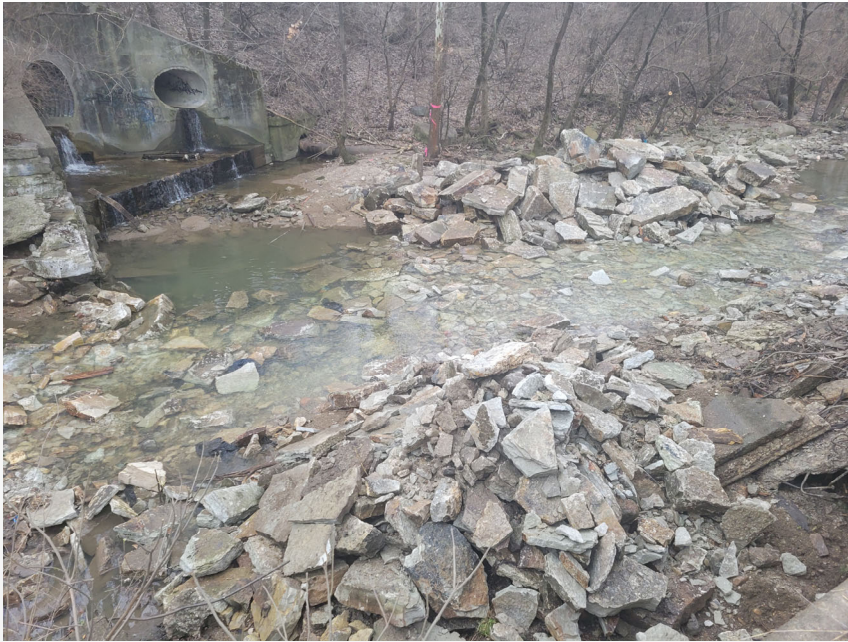
Reuse concrete slabs

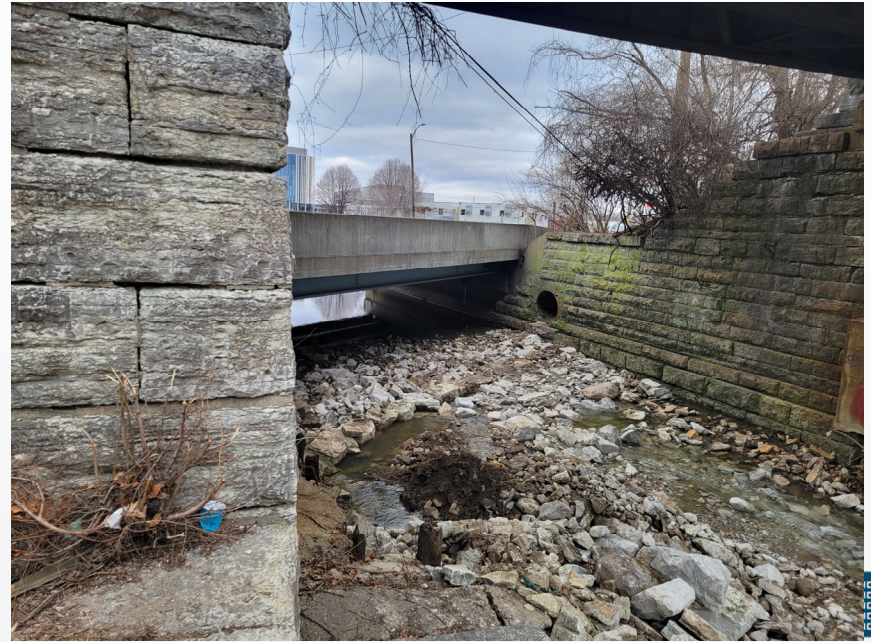
Keyway complete
