EXTENDING THE USEFUL LIFE OF SEWER ACCESS SHAFTS THROUGH CONDITION ASSESSMENT AND REHABILITATION

Five Cities 2017 Conference

Department of Public Utilities
Division of Sewerage and Drainage
Sewer System Engineering Section

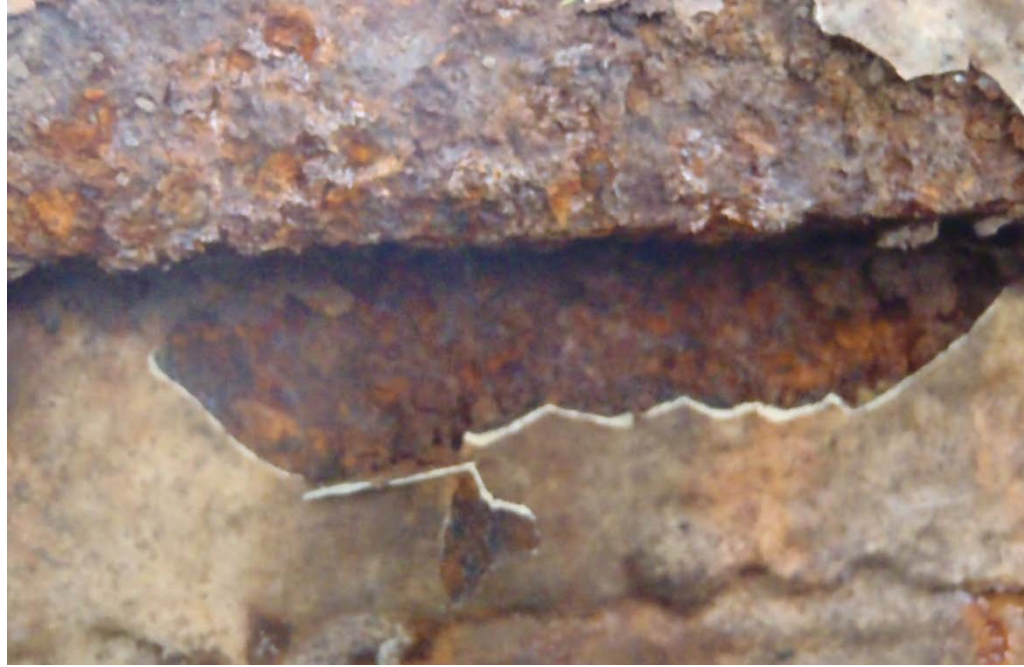
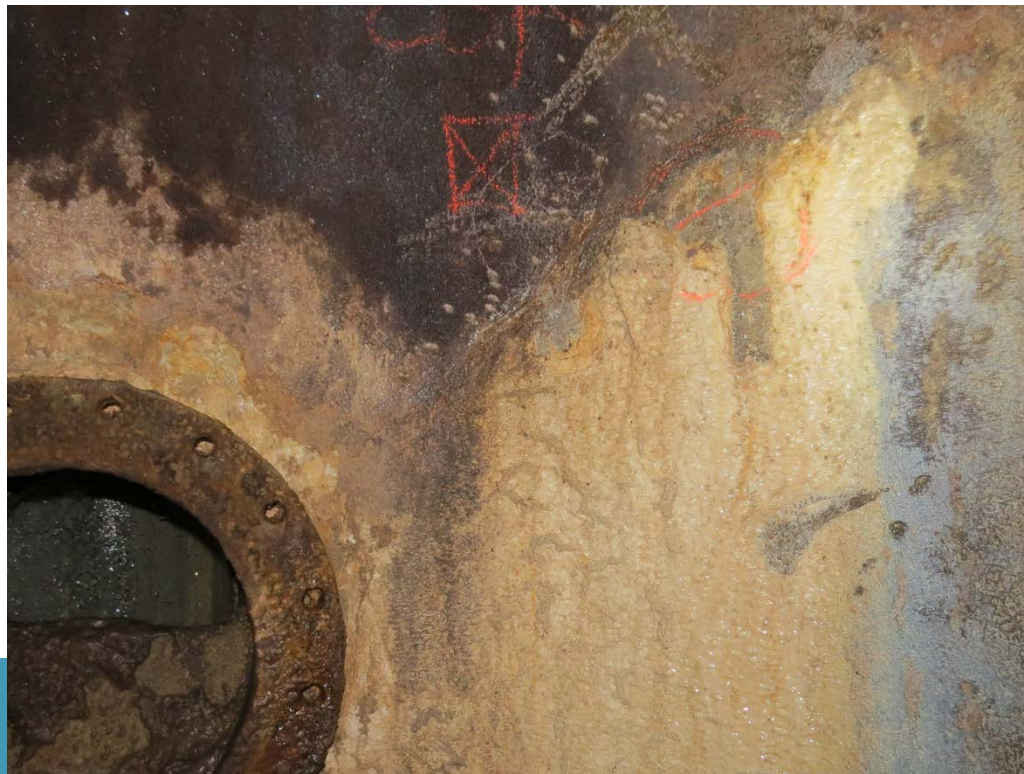
- Visual signs of structural cracking
- Lining deterioration / falling off
- Sinkholes
- Rust spots
- Water leakage
- Material build up
- Odor issues

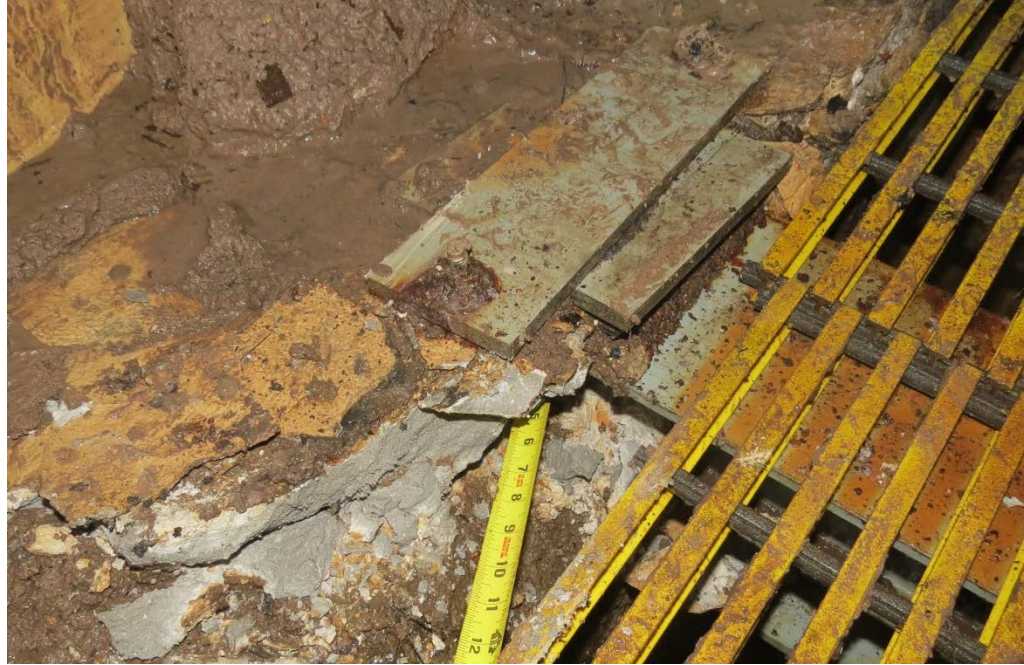
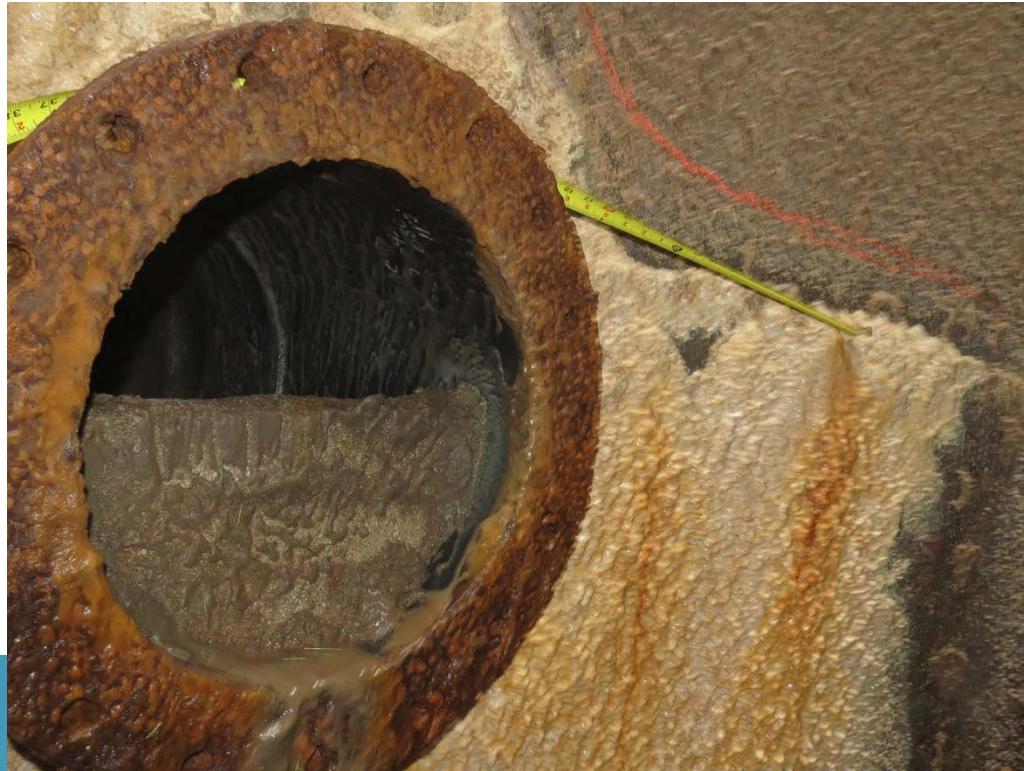
- Broken concrete at the base of the shafts
- Lining falling off
- Material build-up
- Water leaks evident along the shaft walls
- Cracks on the shaft walls

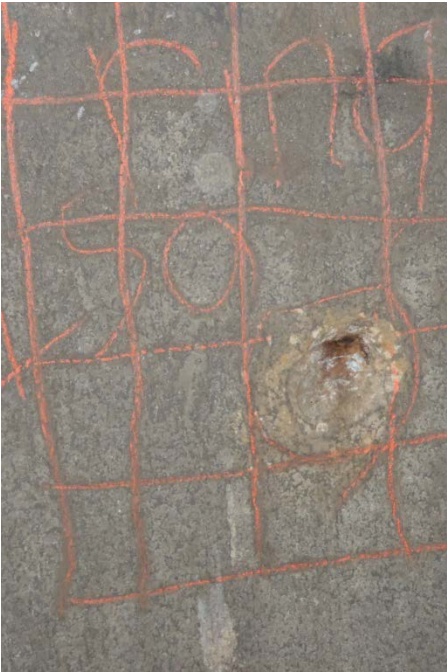
Isopleth Testing

- Visual site inspection
- Visual shaft inspection
 - City assisted with use of their inspection cage
- Sounding
- Schmidt Hammer testing
- Isopleth testing
- Concrete cores removed and petrographic analysis

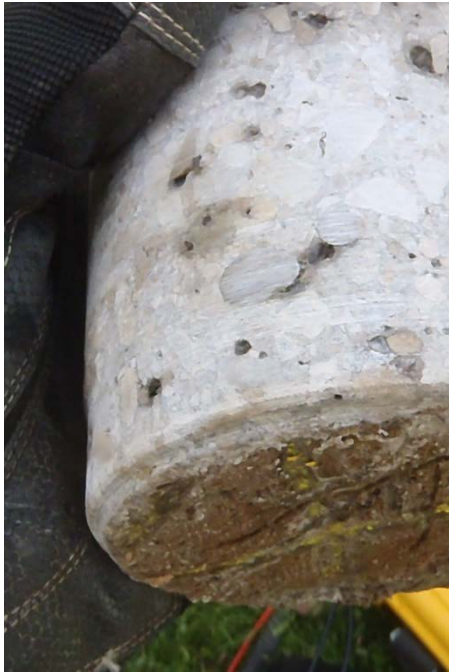
Concrete Cores Removed for Testing

- Concrete cores removed from 6 shafts
- Surface analysis performed
 - Signs of chemical attack
 - Sulfuric Acid
 - Sulfate
 - Reduction in surface material
 - Calcite and gypsum deposits present
 - Water intrusion
- Cement paste tests
 - Cement beyond the surface in good shape
- Compressive strength tests
 - Results varied between 6,630 and 10,400 psi

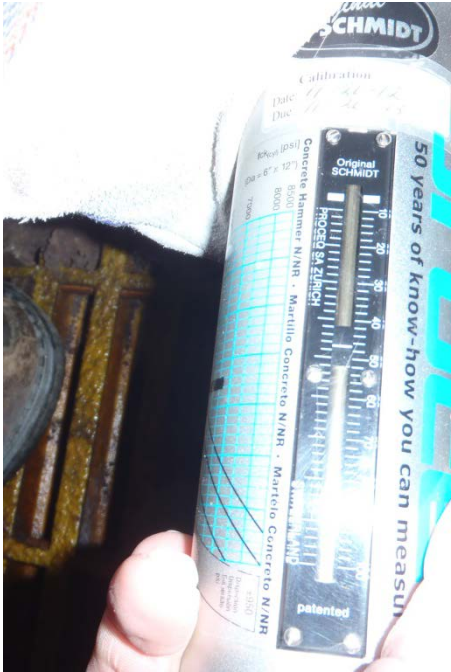
Schmidt Hammer Testing

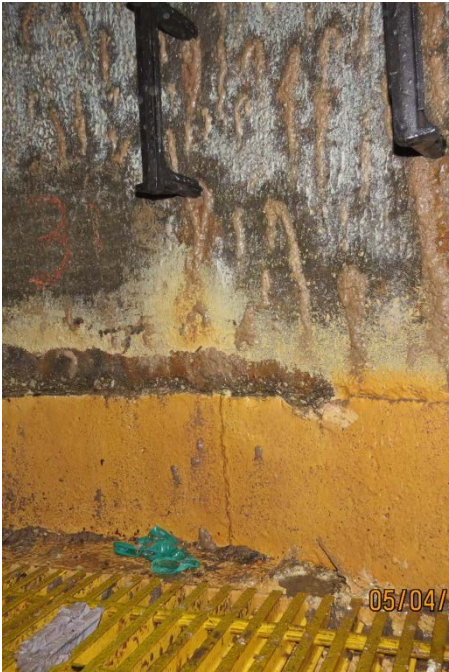
Visual Inspection

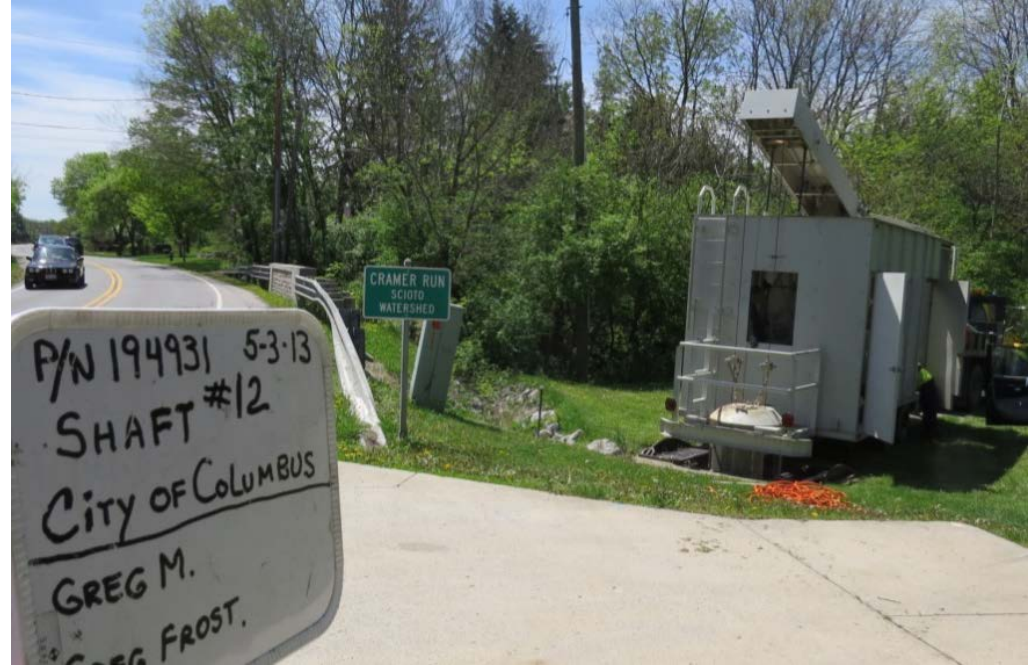
Site Inspection results

- Each shaft site was inspected for access ease
- To gain access to the shafts a heavy trailer carrying the inspection cage must be backed up to the shaft access hatches
- Many of the access hatches are in grass or low lying areas that cannot be accessed during wet conditions

- Provide access pads to 10 shafts to allow for access in any condition
 - Costs range between \$20,000 - \$80,000 per site
- Fix all access hatches
- Coordinate site improvements with appropriate agency
 - City of Columbus
 - Franklin County
 - City of Hilliard
 - City of Dublin

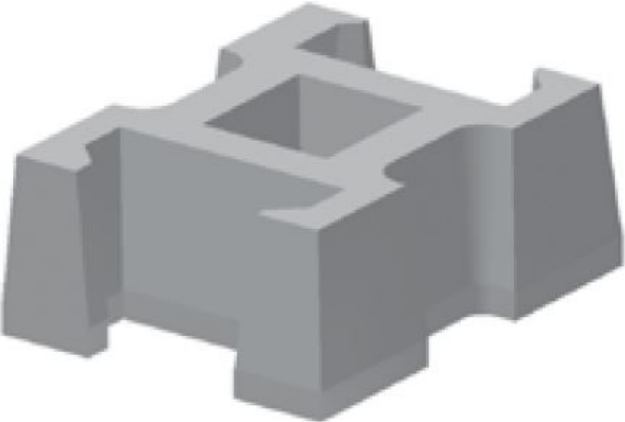
ArmorLoc®

- Structural
- Aesthetics
- Cost
- Installation
- Durability
