Man-Entry vs Multi-Sensor CCTV Inspections of Large Diameter Sewers and Manholes

John Schroeder, P.E.
Drew Richards, P.E.

August 17, 2017

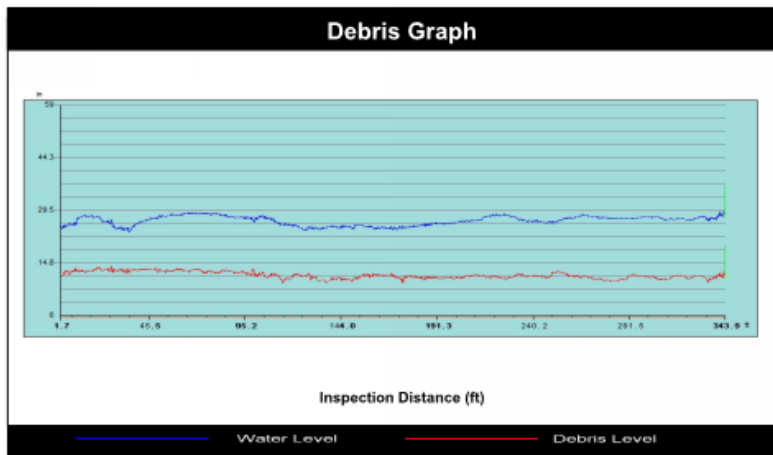
Sonar Data / Graph Review

PCI-74B - PCI-75			
Asset Number	PCI-74B - PCI-75	Length	343.9 ft
Upstream MH	PCI-74B	Dimensions	48" x 59"
Downstream MH	PCI-75	Material	Reinforced Concrete Pipe
Survey Direction	Downstream	Shape	Other
Date Installed		Match to Reference *	312.7 ft
Date Profiled	09 September 2014	Operator

Observations	
Average Debris Depth	12 in
Average Water Level	27 in
Debris Volume	895.4 cubic feet

* The match to reference is the point that best indicates the shape and size of the original condition of the pipe.

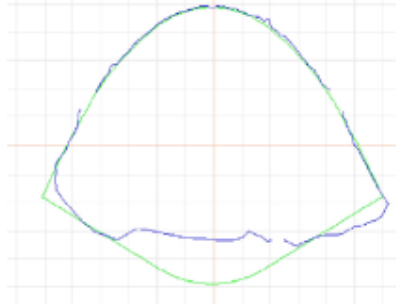
4.2ft General Observation - Measurement outside reference to 1.2", Debris to 8.3"

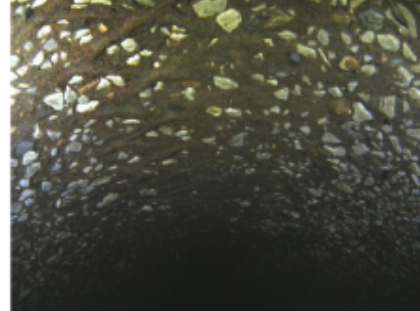
4.2ft General Observation - Measurement outside reference to 1.2", Debris to 8.3"

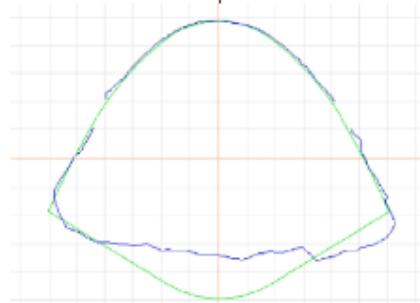
45.7ft Maximum measurement outside reference - To 1.6"

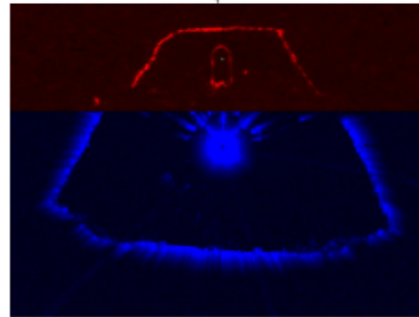
49.9ft General Observation - Measurement outside reference to 0.6", Debris to 8.0"

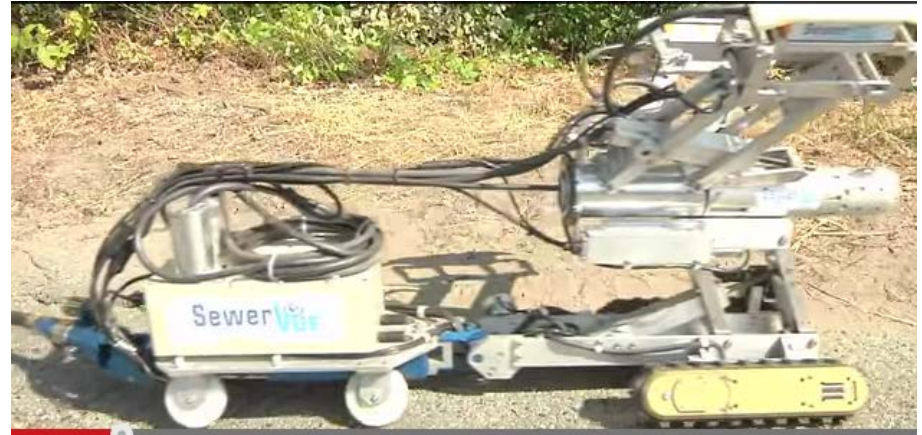
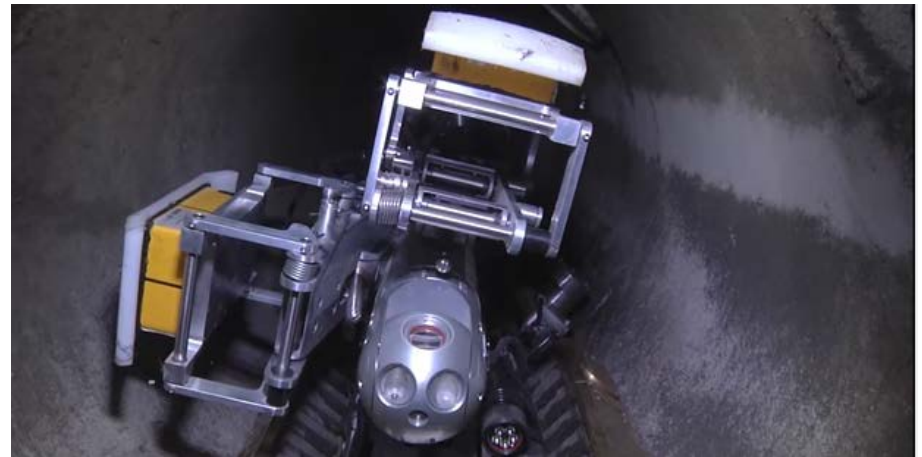
Pipe Penetrating Radar (PPR) Case Study: Cochella Valley CA

- SewerVue
 - In-Pipe Ground Penetrating Radar
 - Identify and quantify voids behind the pipe wall
 - Approximates wall thickness
 - Robot rotated sensors between 9 o'clock & 12 o'clock
 - Rotated sensors between 10 o'clock and 2 o'clock on return

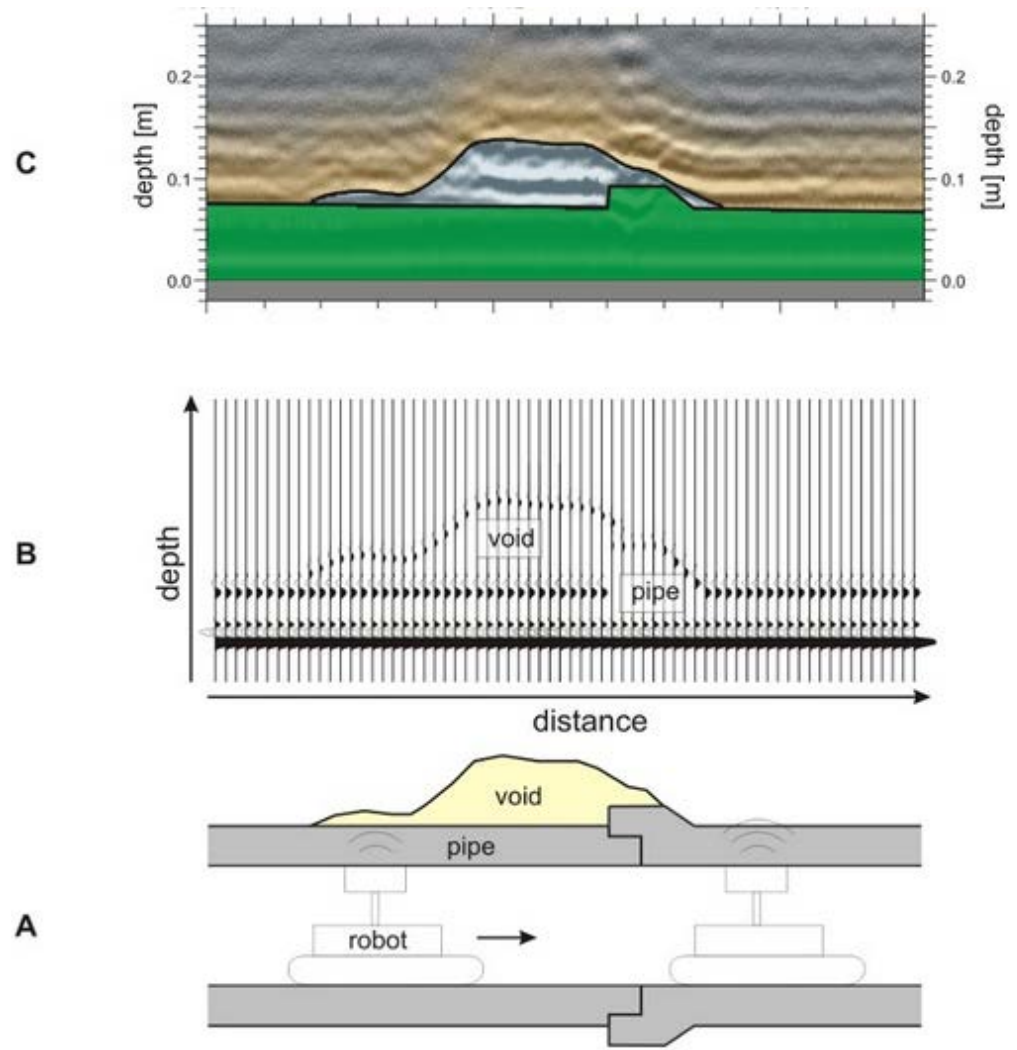
Pipe Penetrating Radar (PPR)

- SewerVue
 - In-Pipe GPR
 - Can identify and quantify voids outside/behind the pipe wall
 - ~\$10 per foot

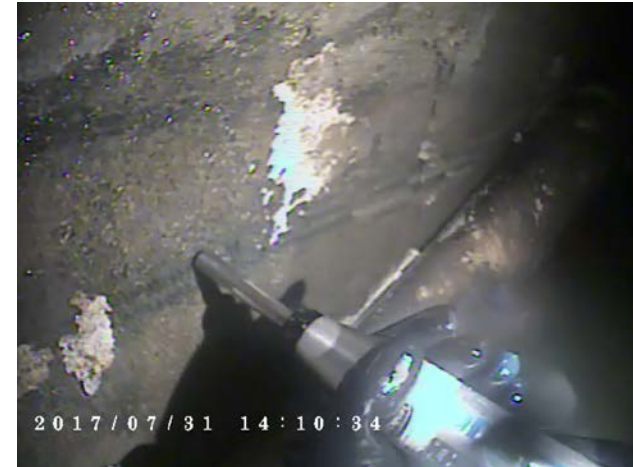
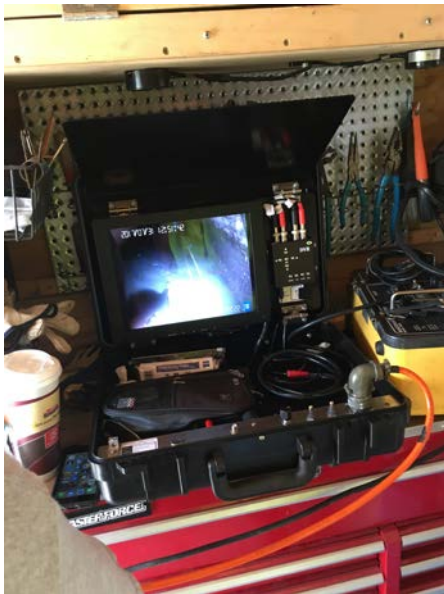
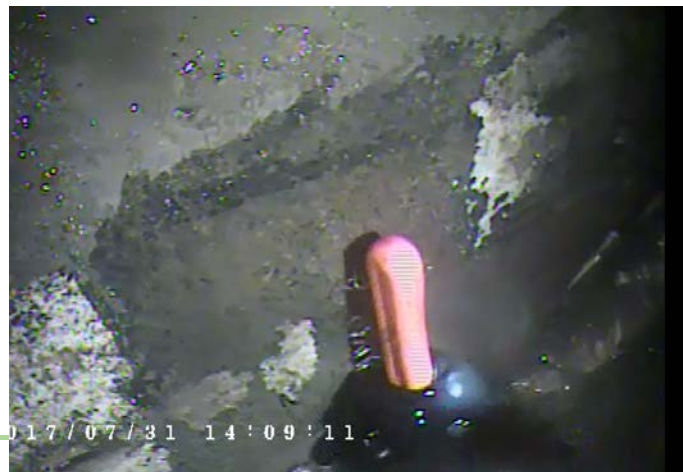
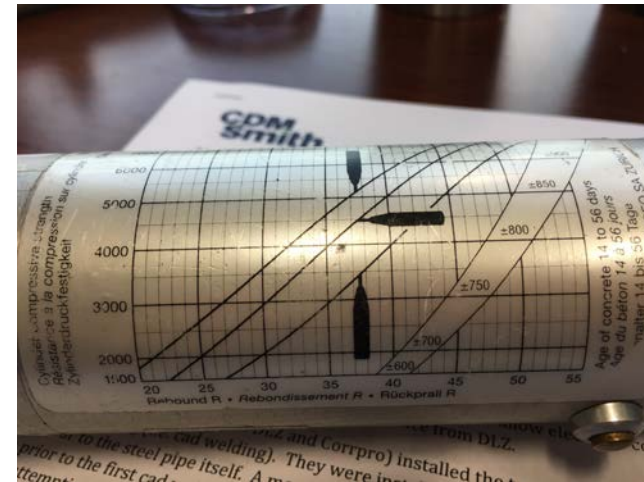
- Schmidt Hammer Test
- Six test on each side of pipe
- Avg. 54 = 7700 psi
- Avg. 50 = 6700 psi

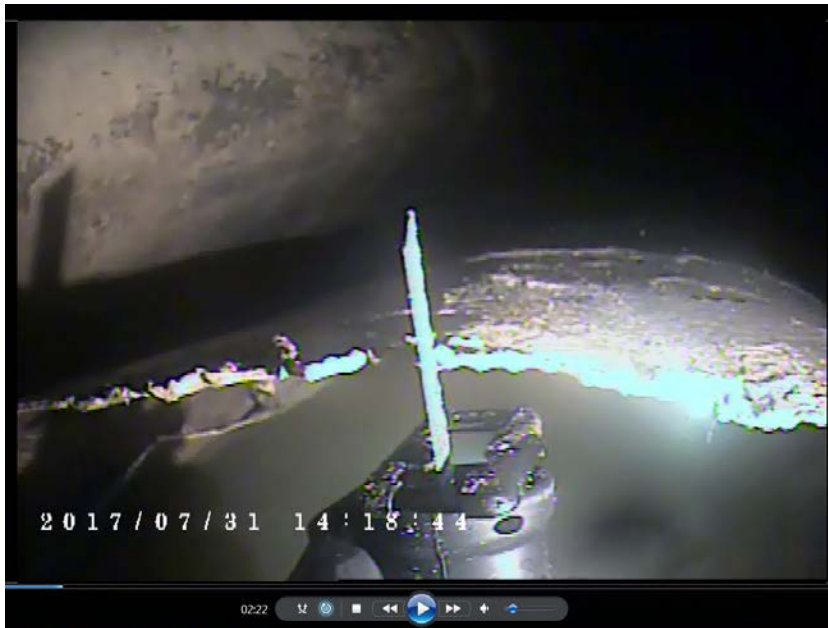
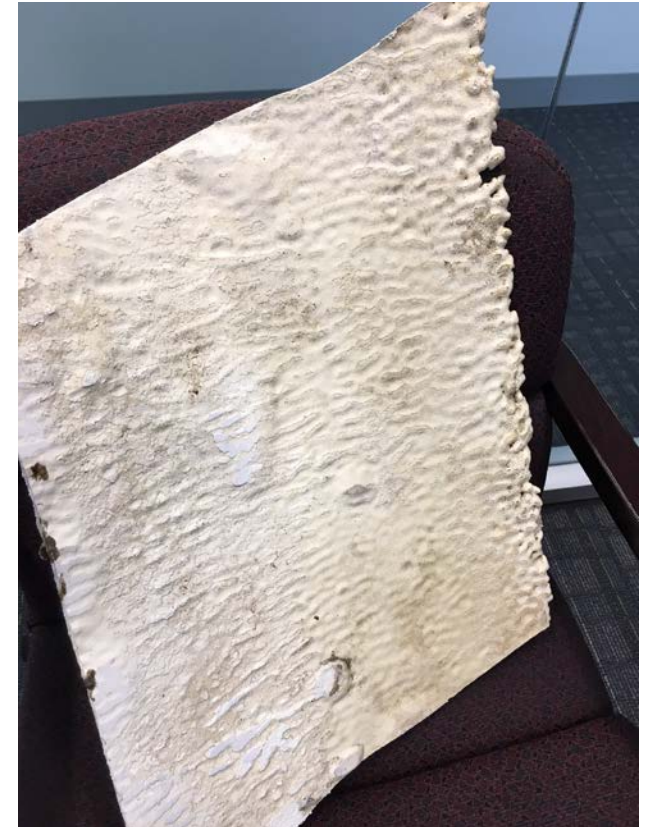
- Successfully performed Schmidt Hammer test
- Confirmed pipe wall is sound
- Removed portion of failing liner
- Determined length of blockage ~44 ft
