**Where Have You *Bean*?
*Outreach and Innovation to Avoid
Sewer Failure at Bean Creek***

August 17, 2017

**Craig Cordi and Olivia Hawbaker
Citizens Energy Group**

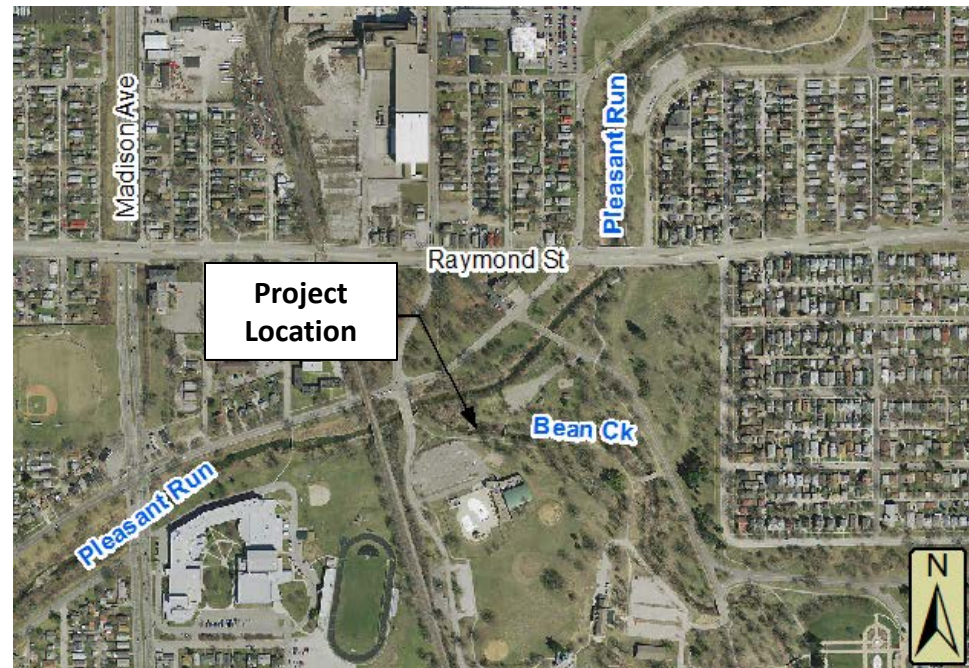
- Site location: Garfield Park
- The problem...
 - 48” sanitary sewer interceptor with shallow cover under Bean Creek
 - Complicated stream dynamics and long history of issues

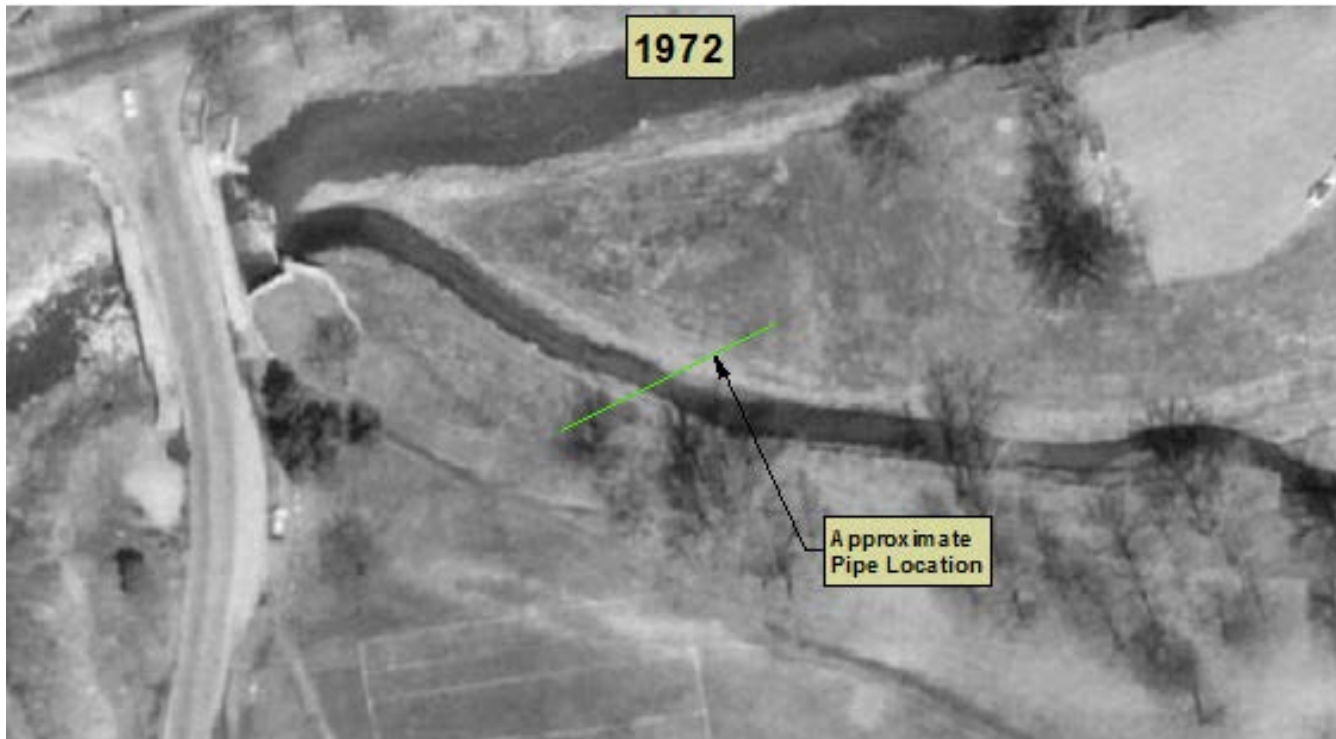
- By 1972, the confluence of Bean Creek & Pleasant Run had taken on its current configuration

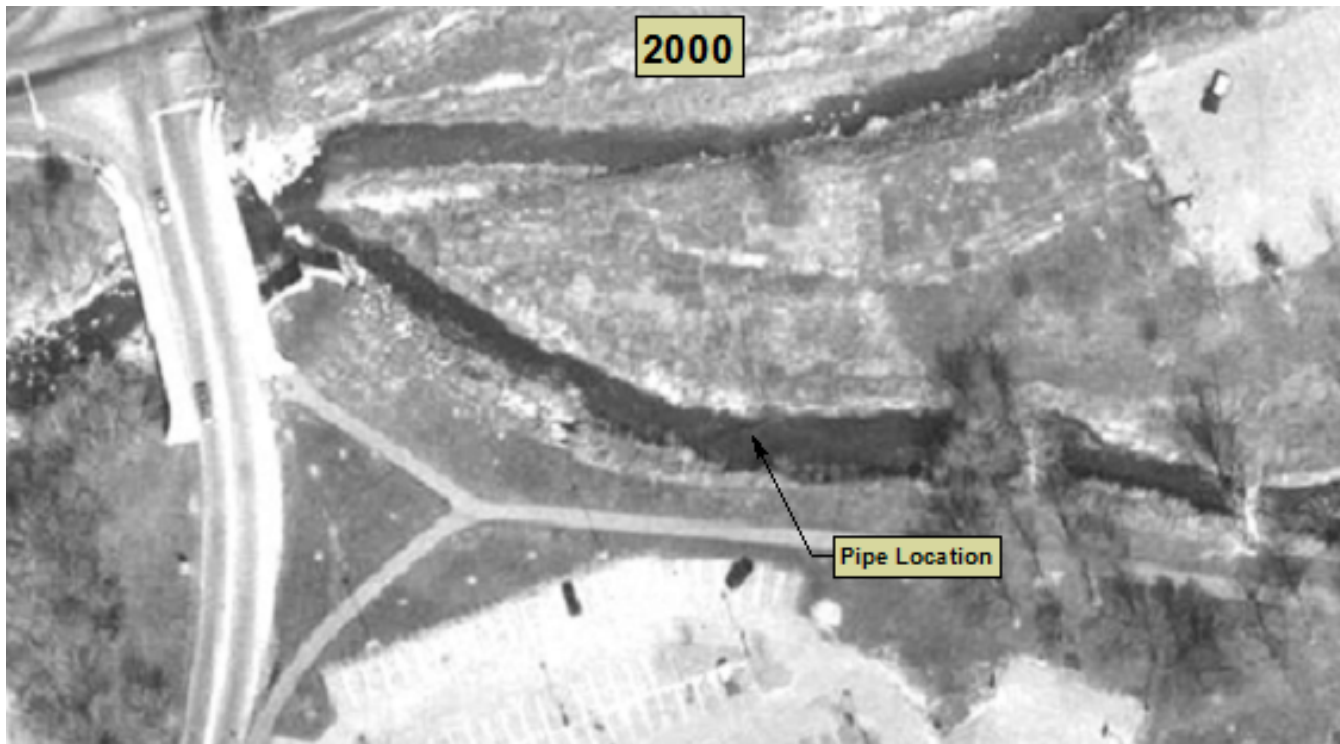
- By 2000, the interceptor line was becoming visible in the bed of Bean Creek

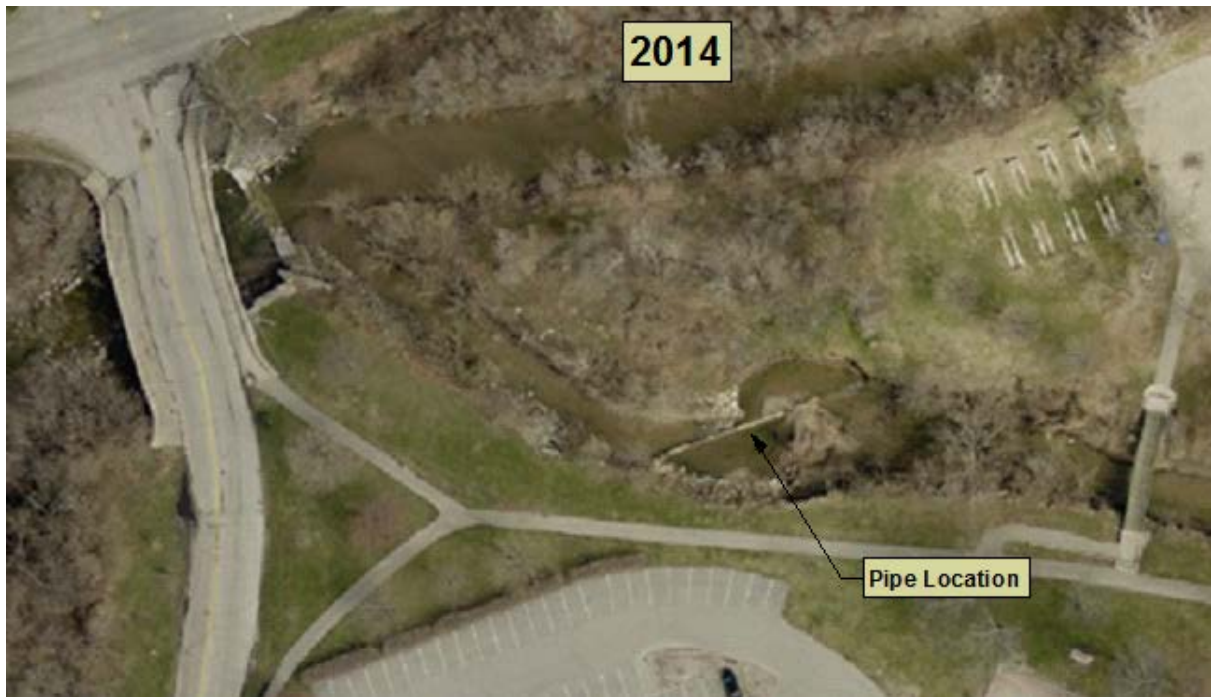
- A large storm event in 2014 caused a significant bank failure and completely exposed the pipe

Problem: A large storm event in 2014 caused a significant bank failure and completely exposed the pipe

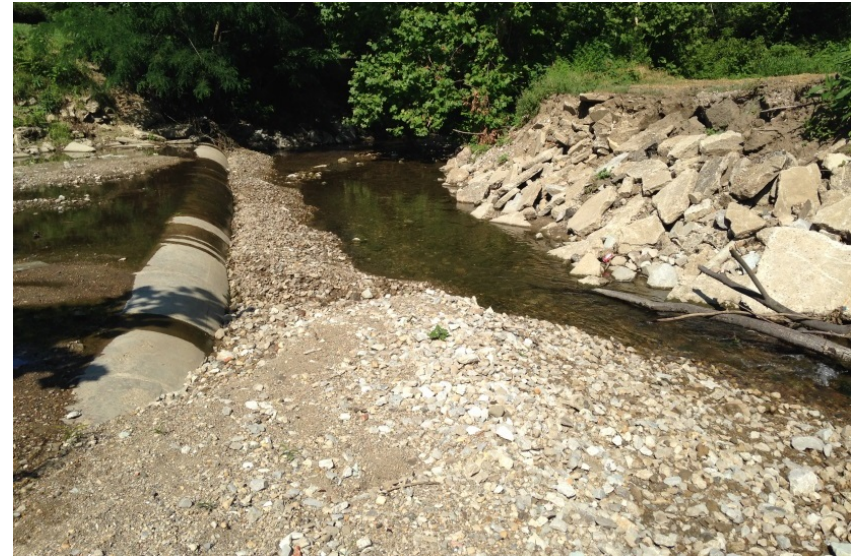
CIPP Lining

- Rehabilitation of exposed segment
- Cured-in-Place Pipe (CIPP) lining
 - 520 LF of 48-inch interceptor
 - Existing on-call contract with Layne Inliner and Wessler Engineering

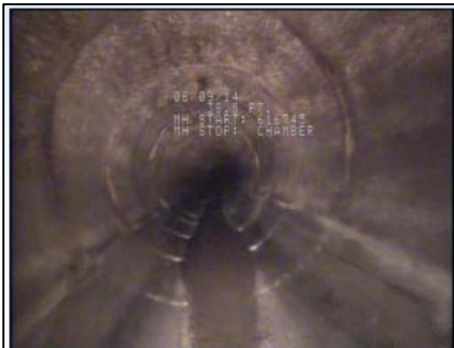
Pre-CCTV Condition

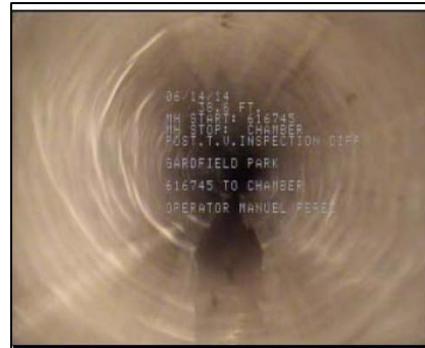
Finished CIPP liner

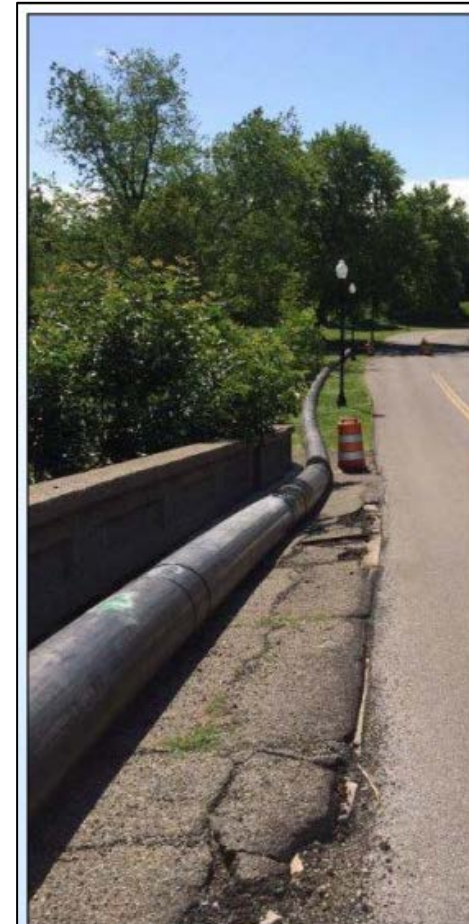
- Bypass pumping
 - 2,000 LF and 13 MGD total
- Results
 - Eliminated leaks
 - Increased structural stability

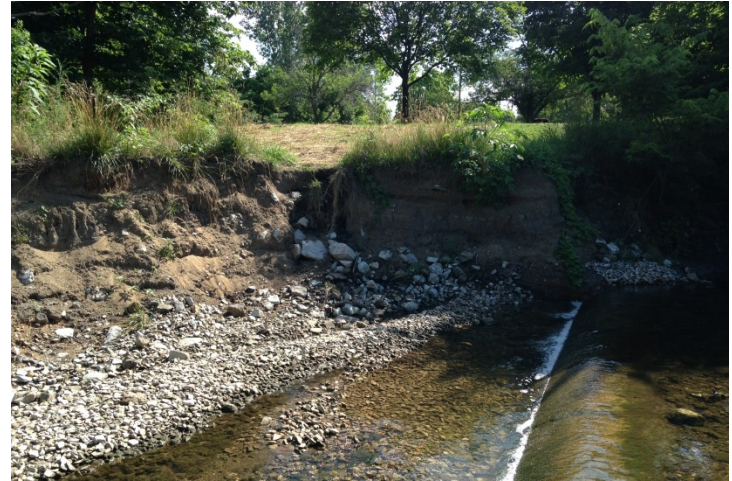
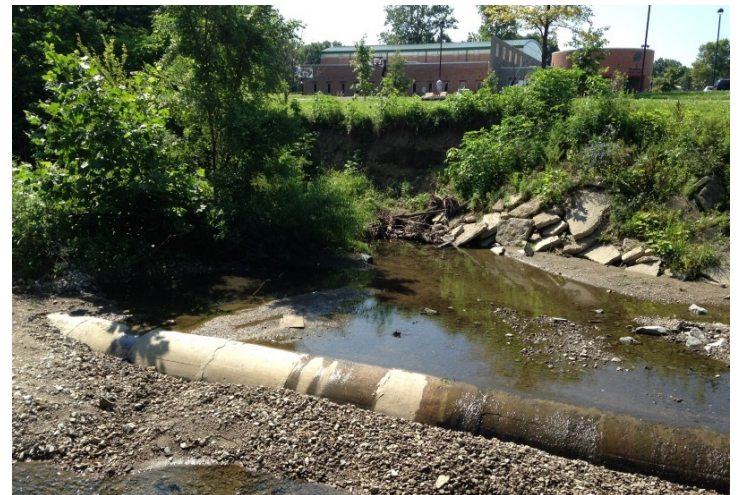
- Long-term concerns:
 - Further undercutting of pipe
 - Additional bank erosion that may impact:
 - Interceptor
 - Greenway
 - Release of sediment
 - Ecological resources

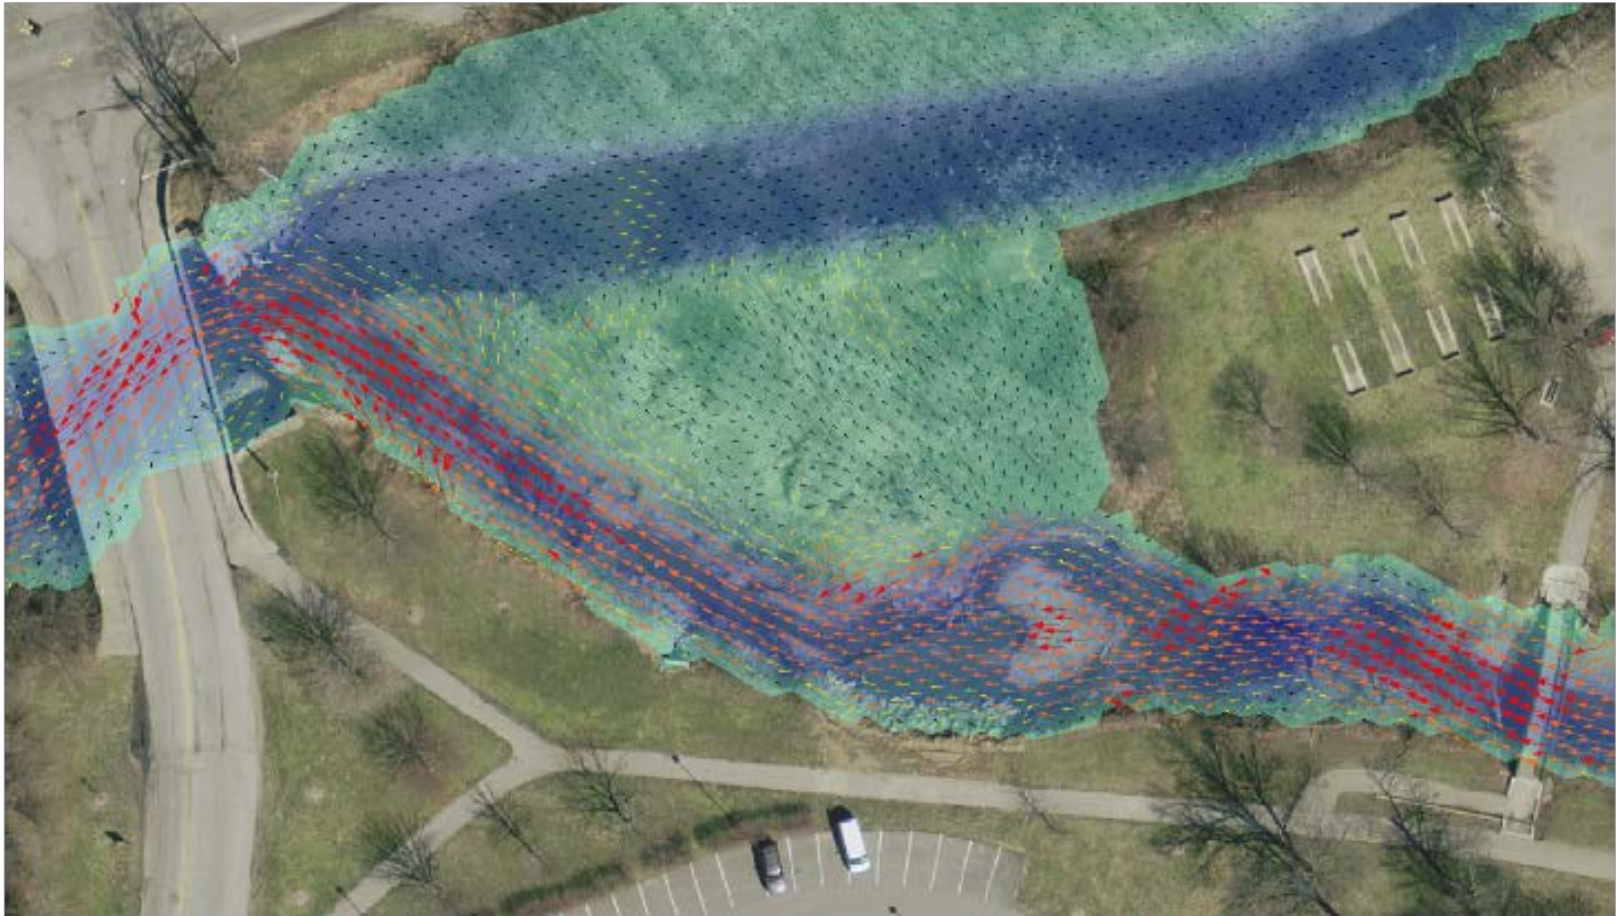
- Detailed 2D Model used
 - Evaluate impact of various storms
 - Assess effectiveness of conceptual solutions
- Model showed that flow has qualities leading to channel instability
 - Flow is poorly aligned, directed at channel bank
 - High flow velocities, capable of substantial erosion
 - Downstream of sewer, channel incised and actively degrading

Figure 2: Existing Condition Isolated 100-year, 12-hour Storm Event – Peak Velocity Vectors & Flow Depth

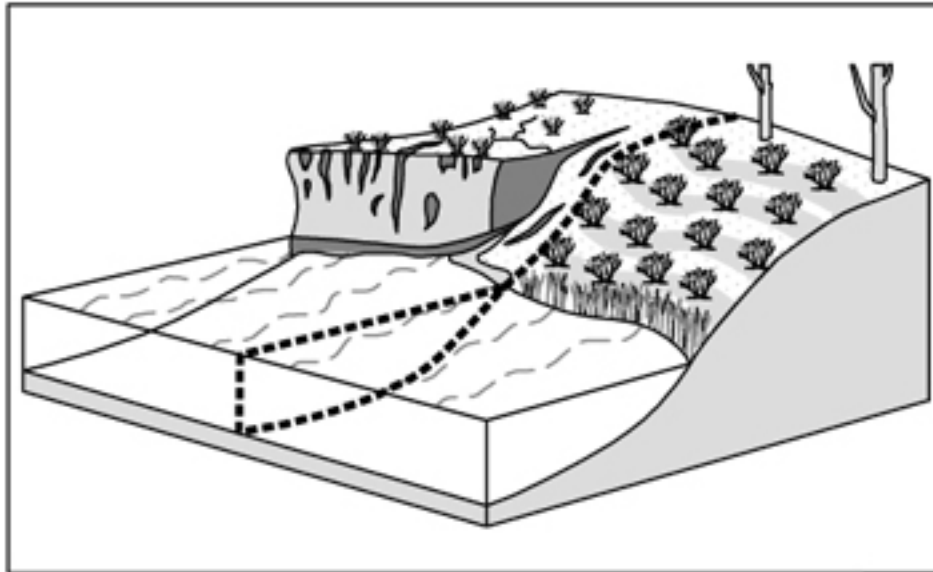
- Lower velocity, Less erosion
- Increases stability of the channel bank

The slope of the area will also be improved to assist with the water flow by lowering the flow's velocity and thus resulting in less erosion. Ultimately, this improvement will increase the overall stability of the channel bank.

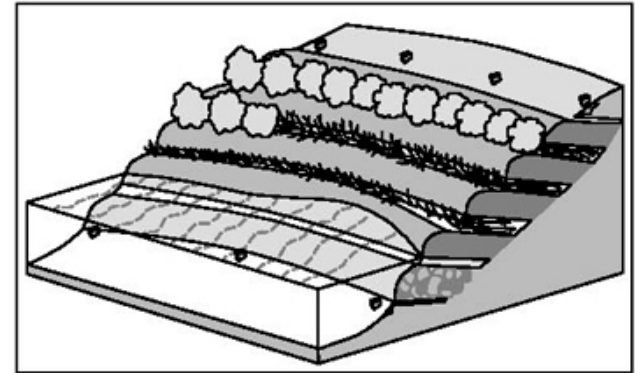
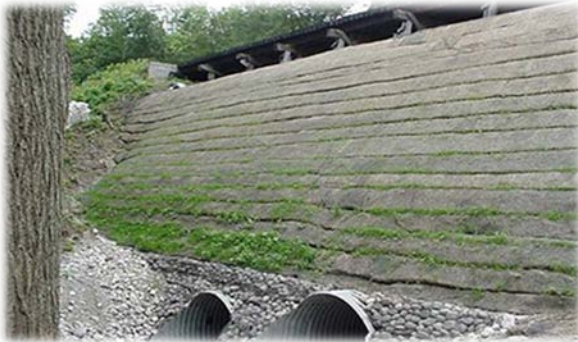
- Vegetated ‘green’ solution
- Substantial erosion resistance that continues to increase as vegetation becomes more dense

In an effort to be consistent with other Indy Parks projects, Citizens will use a green (natural) solution known as Vegetated Mechanically Stabilized Earth (VMSE) to provide substantial erosion resistance that will improve over time as the vegetation fills in and becomes more dense.

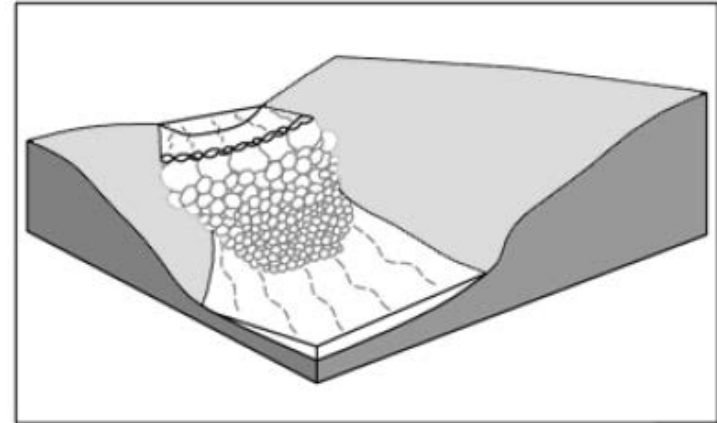
- Protect toe of channel to avoid erosion
 - Cause of previous instability
- Fixed channel elevation to provide minimum pipe cover
- Flow redirected to center of stream

Figure 1: Schematic Drawing of Newbury Rock Riffle

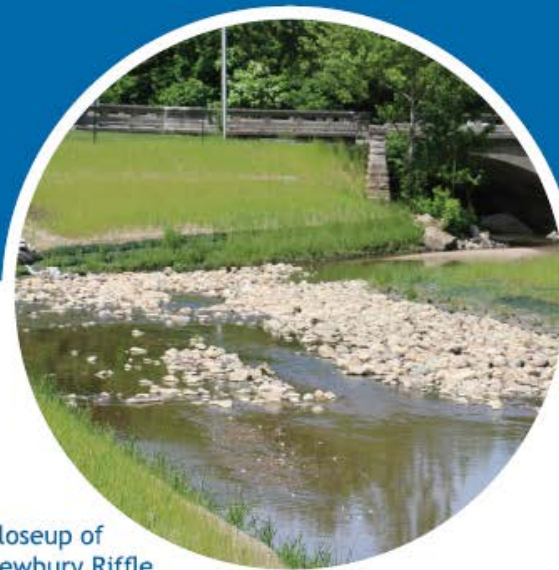
Closeup of
Newbury Riffle

In 2014, a large storm event caused a significant bank failure along Bean Creek and completely exposed the once buried sewer pipe crossing underneath. Utilizing sustainable solutions like Newbury Riffle (boulders in the channel designed to simulate the natural creek bed and provide controlled streamflow), willow stakes and native grass, Bean Creek restoration was completed in 2017 to protect the creek banks and the existing large sewer beneath the creek.
