SODIUM HYPOCHLORITE: Problems in Solution

Tom Sanderson City of Akron Water Reclamation Facility

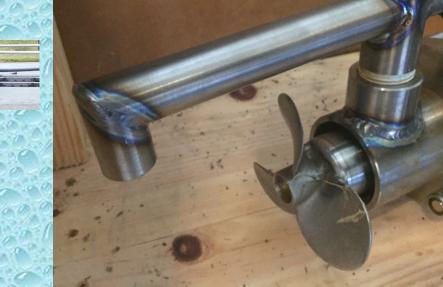
SERIES 32PT EXTERNAL CHEMICAL FEED FEED HOSE

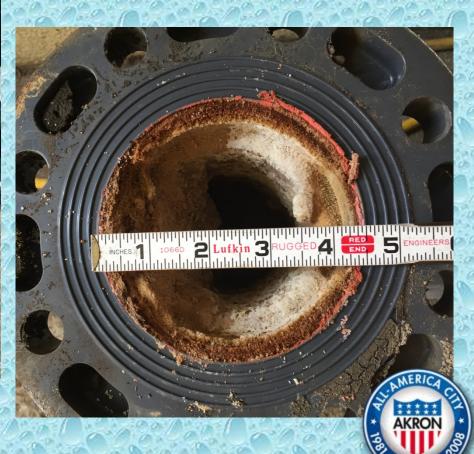
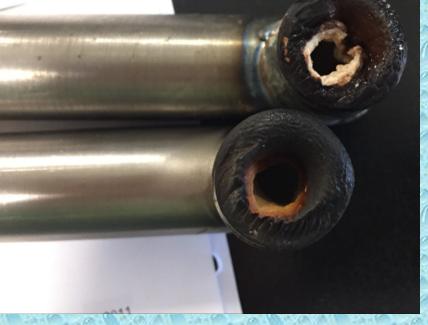
Chemical Line With "Potato Chips"

Before Periodic Cleaning in Dilute HCl

After Cleaning

- Determined that carry water was the cause of scaling.
 - Had lab run hardness tests
 - Appeared to be due to initial change to injection mixers. Did not account for the chemistry
 - BleachTech was very helpful in helping track down issues.
- Tried NPW and PW. No improvements.
- Determined feeding "neat" was the solution

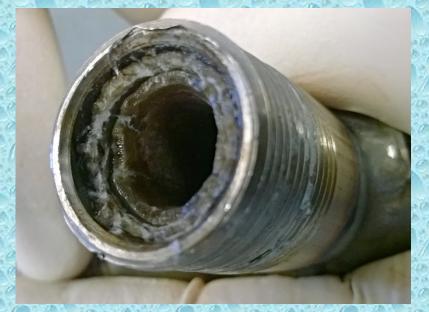
Before Periodic Cleaning in Dilute HCl

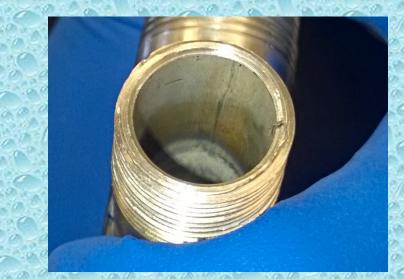
After Cleaning

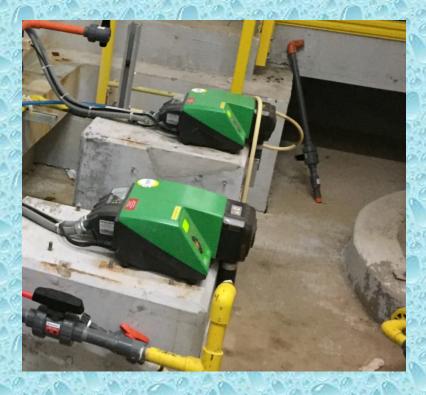
Installed two peristaltic feed pumps.

- Watson Marlow Brand 520D
- One pump per mixer

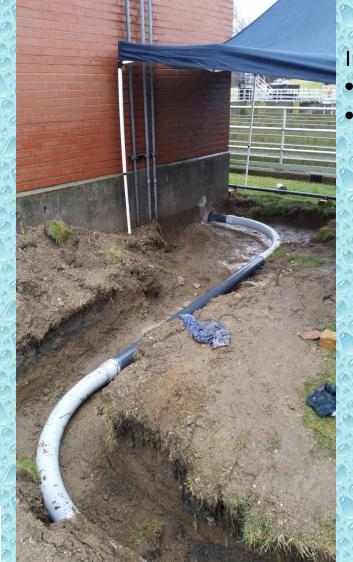
Installed 4" SCH80 PVC.

- For use as carrier pipe
- Installed long sweep elbows

- Contracted local plumbing contractor (JTP) to install color coded PEX-B lines.
 - 4" carrier pipe made install easy
 - Cost just over \$1,600 to install
 - For easy removal of mixer, whips were added
