Protecting our Infrastructure in Streams

Allison Walker - Citizens Energy Group
Andrew Miller - Christopher Burke Engineering

2023

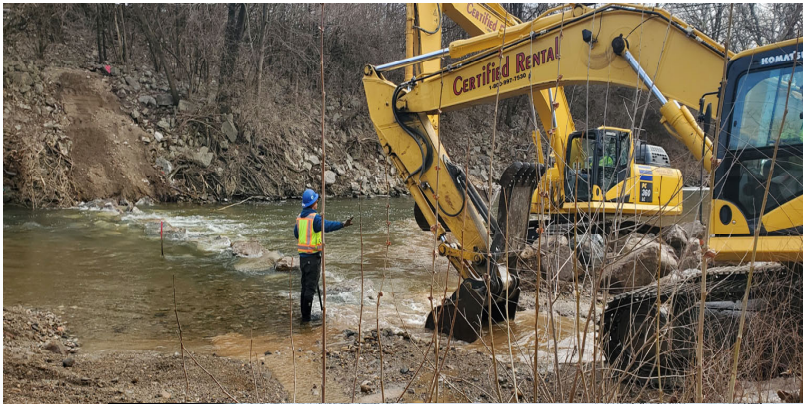
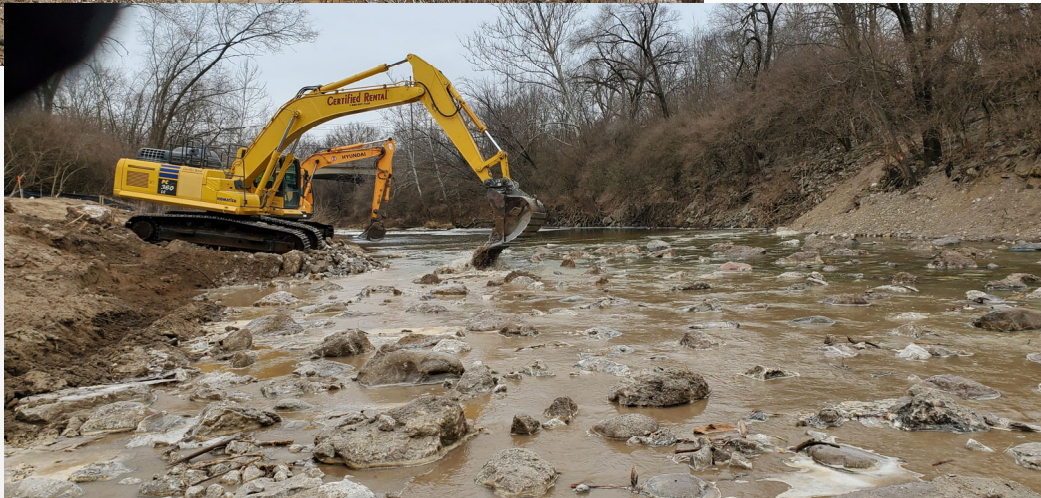
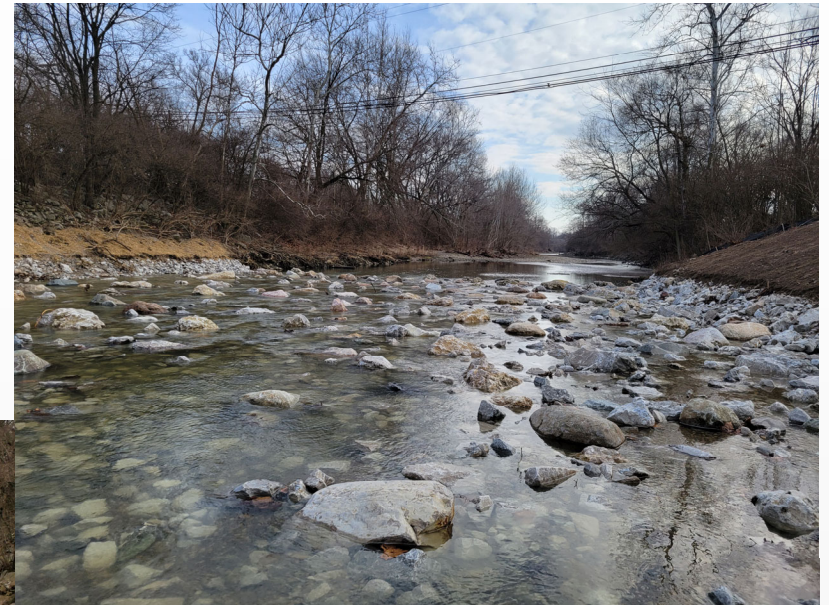
Construction Photos

- 36” Watermain
 - Main transmission line. Can not be taken out of service
 - Levee on south bank
 - 30’ elevation change on both banks
 - Floodway (IDNR Permit Required)

Solution: Newbury Riffle

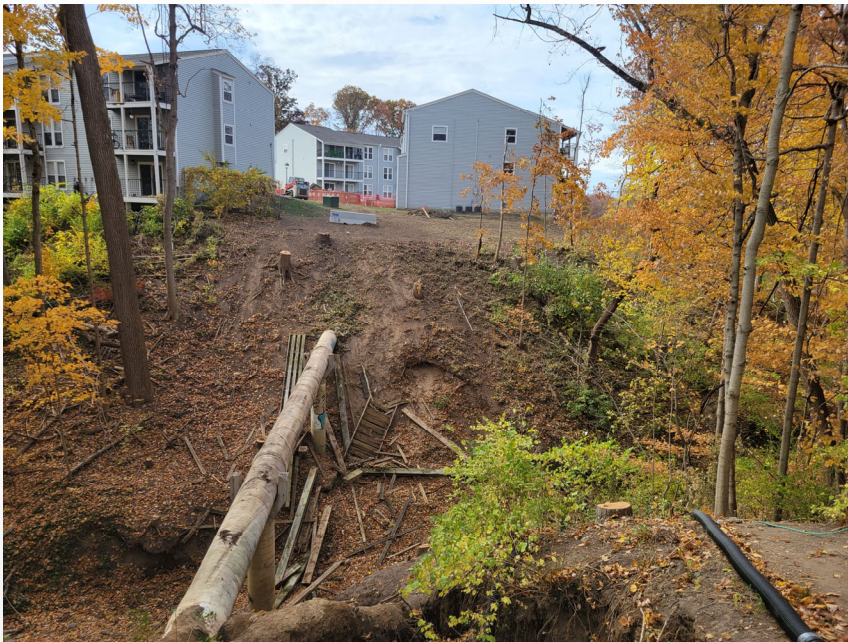
Looking South

During construction

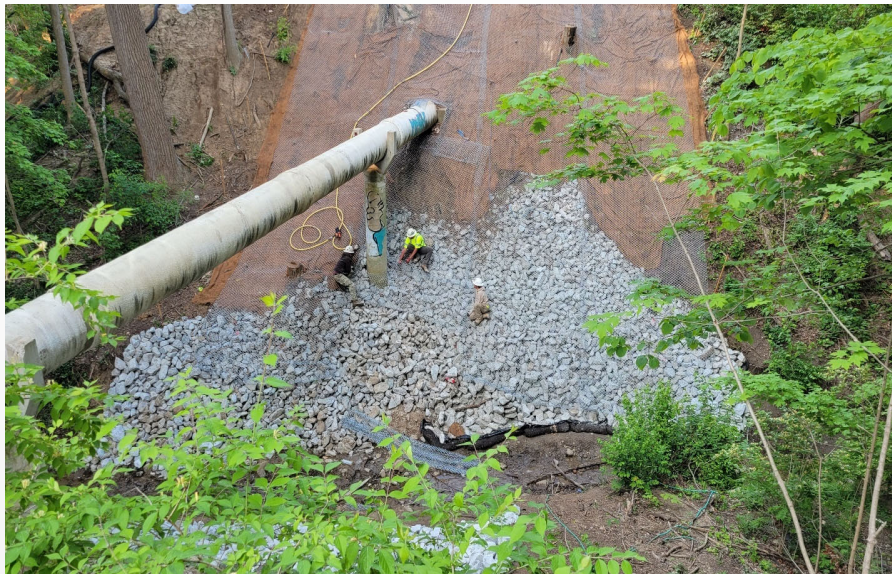
Looking South

Final Condition

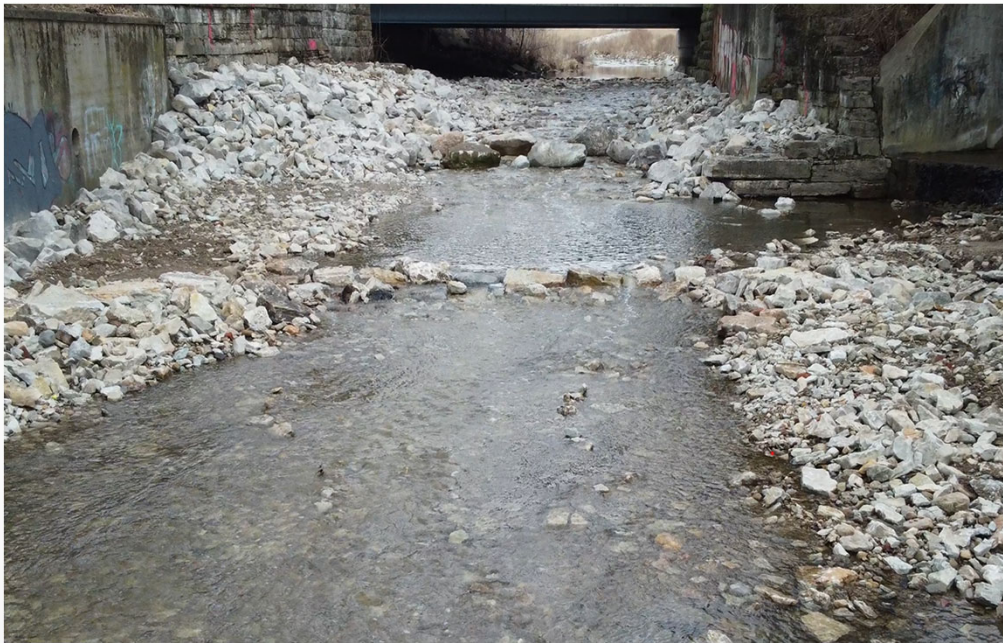
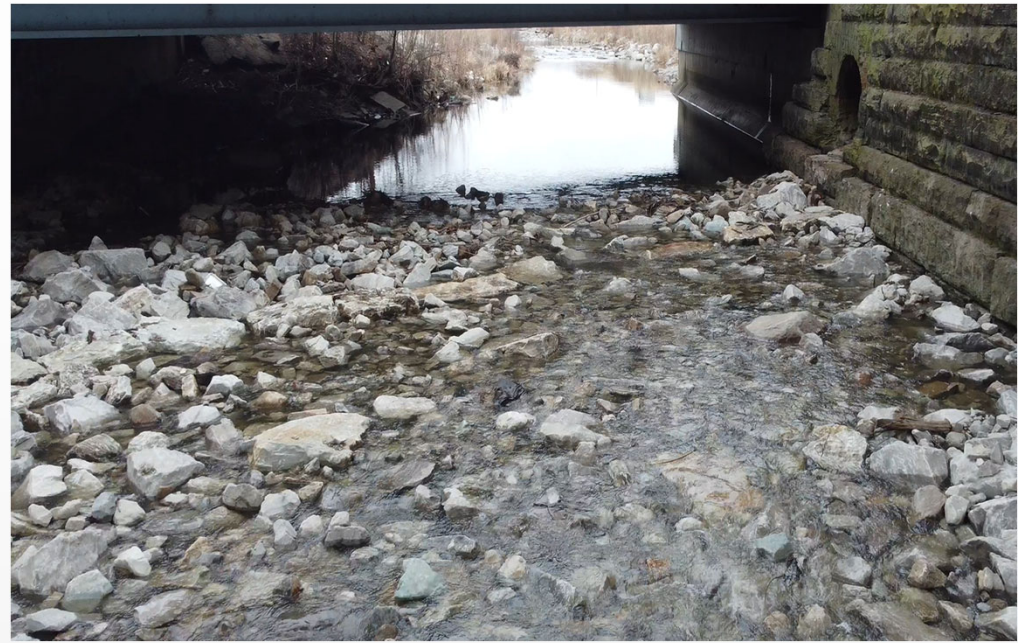
Final Condition

- Exposed sanitary sewer
- Exposed watermain
- Failed low-head dam
- Existing CSX bridge
- Mapped Floodway
- 5' of elevation fall within the channel

- Relocation
 - Possible but very high costs
- Instream structures
 - Riffle at each utility
 - Boulder cluster
 - Rock cross vane
