Proactive Solutions Provide Success on a Fast-Track Project A Discussion of Lessons Learned on a Time Sensitive Sanitary Sewer Project

Michael Wytrzyszczewski, City of Akron Bryan Celik, H.R. Gray

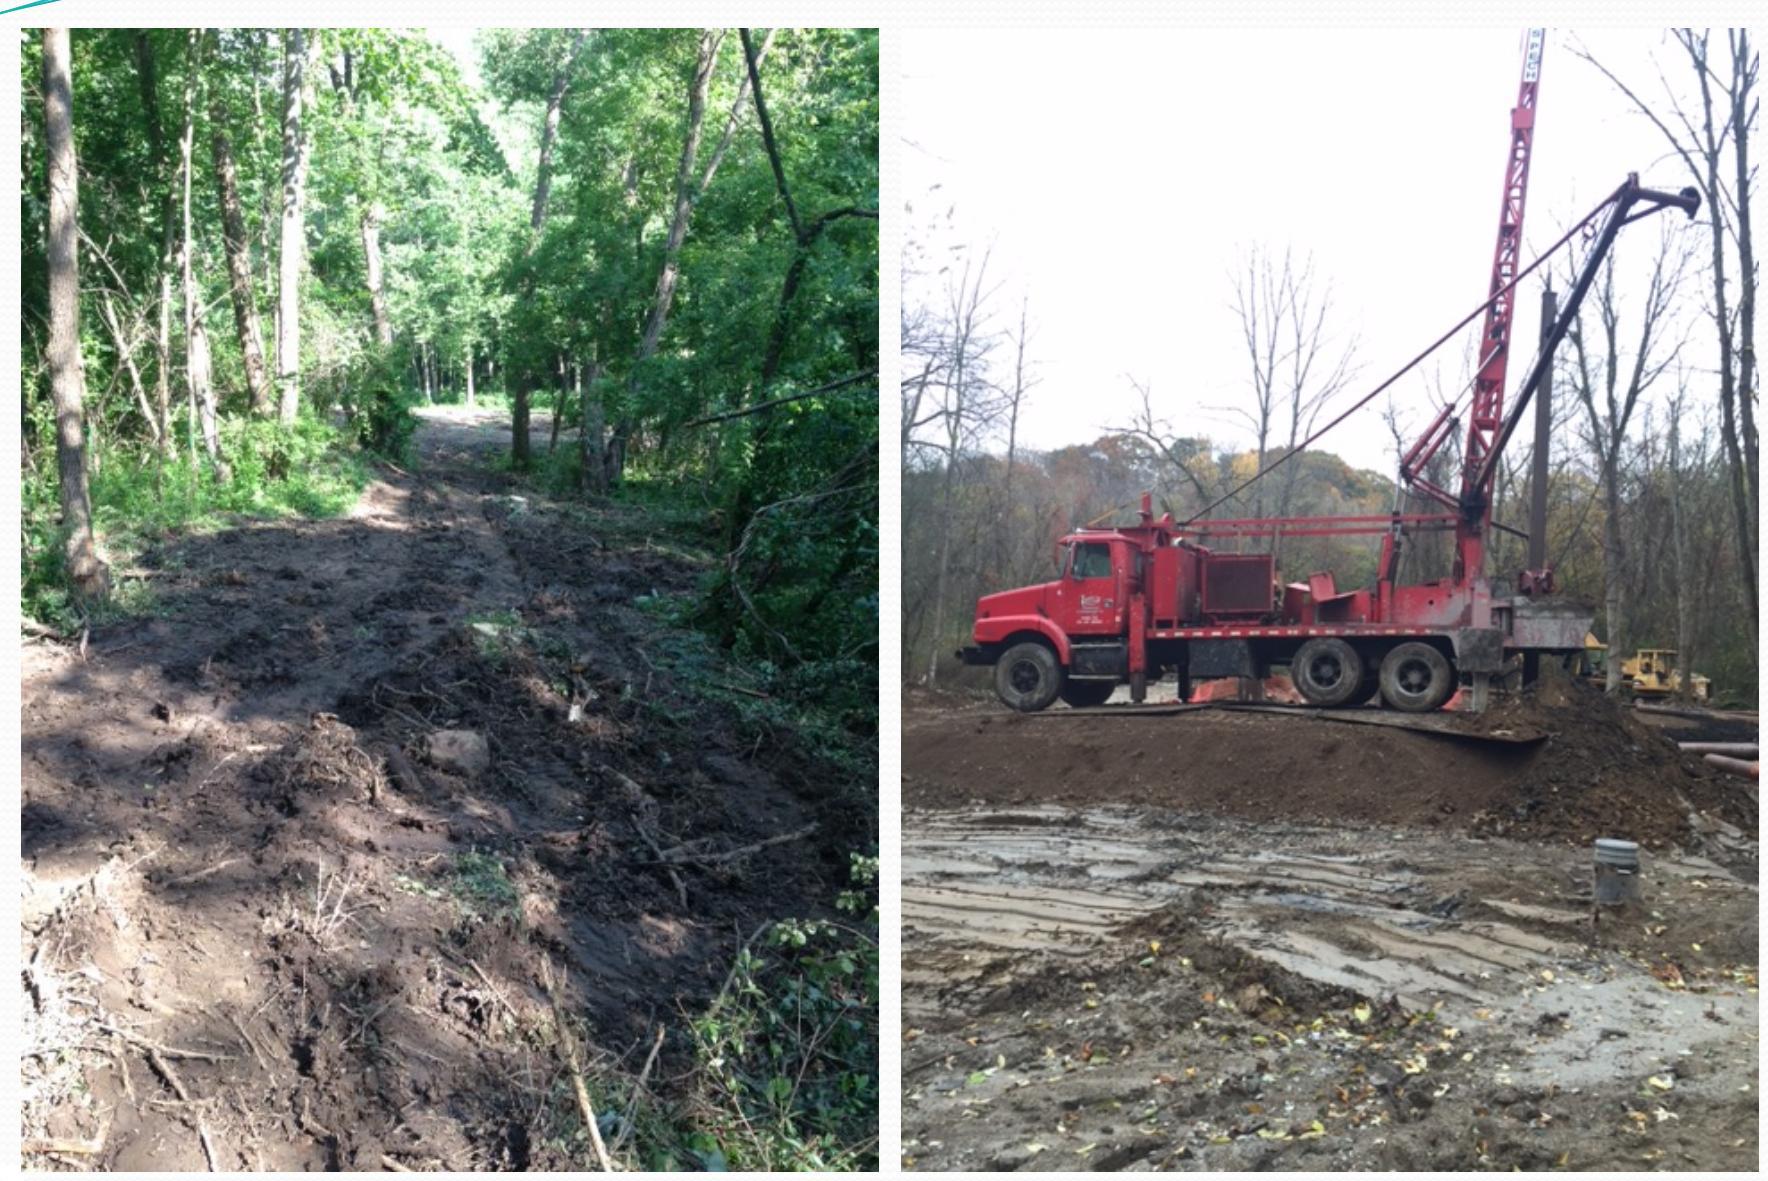
Example: Obstruction in 72" storm sewer

- Located 500 feet from main road, inside Summit County Metro Parks
- Backflow from river, assumed debris obstruction
- Attempted video surveillance twice
- Excavation in multiple locations
- Pipe sunk pipe run of 200 feet had to be replaced

- Unstable conditions required structural solution before pipe could be replaced
- Spent 2 months developing design that would structurally support new pipe
